McNeilage Conservation

St. Britius Church, Brize Norton

Condition Survey Report

August 2012

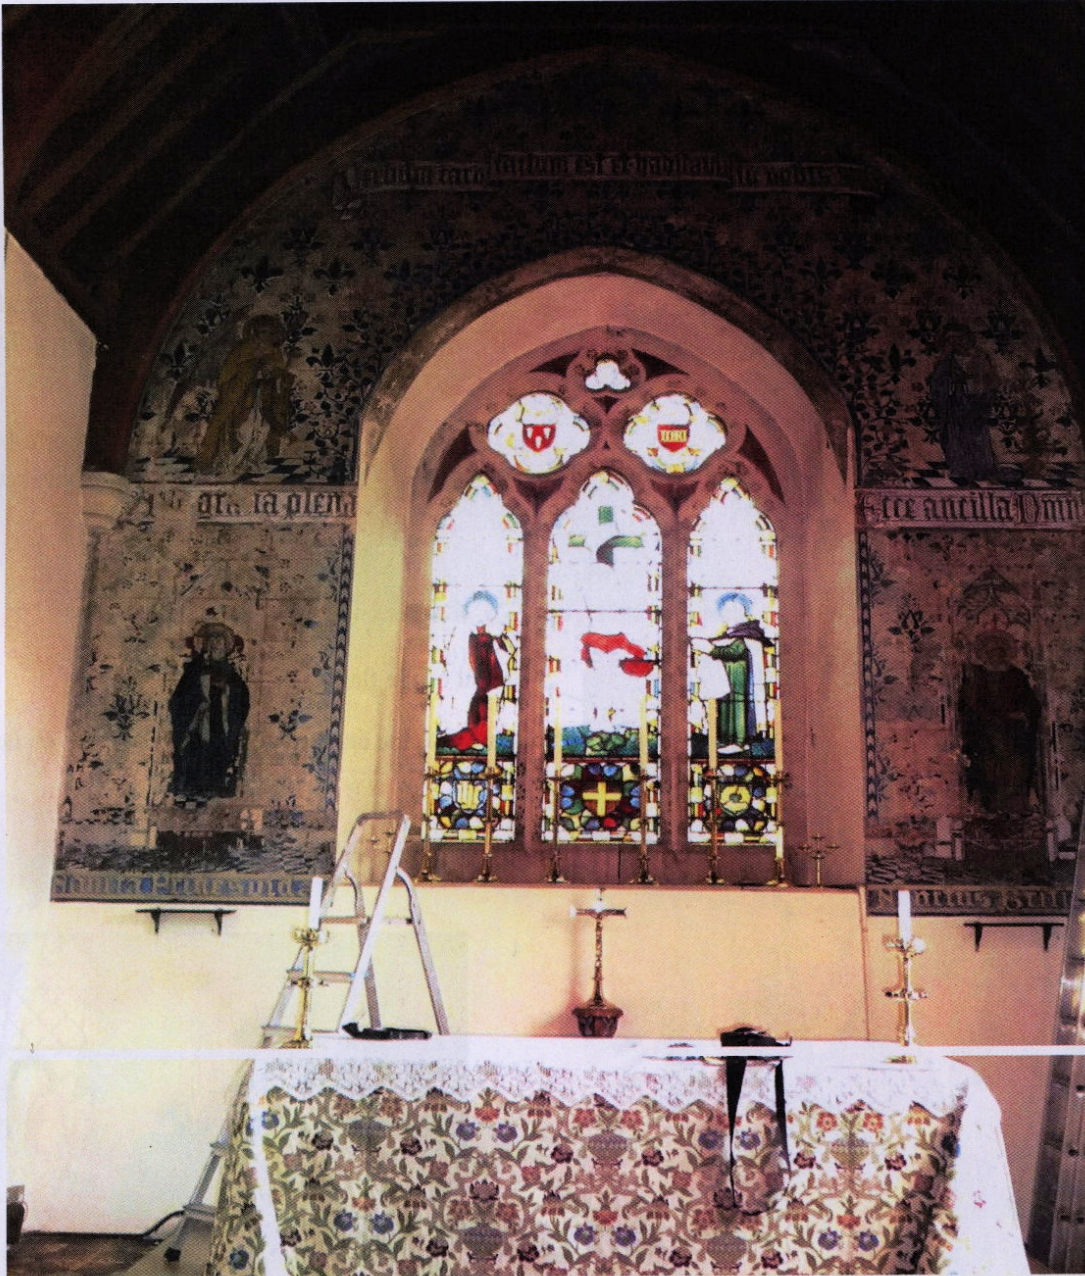
1

View of the east wall

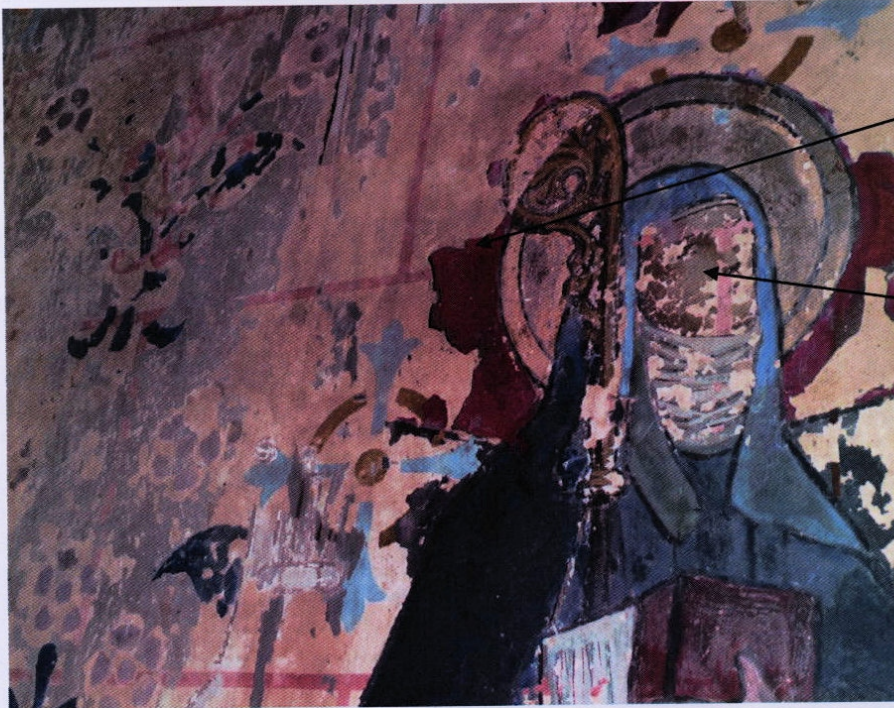
2

Detail showing St. Frideswide. Note the curling back of the red background colour which has been over painted with oil paint.

The remaining paint on her face also appears to be discoloured and may have an organic coating.

Most of her robes have been heavily retouched

Some of the later retouching is extremely disfiguring to the painting and it would be appropriate to remove it. The areas that particularly stand out are:- both ends of the upper scroll (see plate 11&12); the green on the front of St. Britius' robe (see plate 15) , the blue on the headdress of St. Frideswide (plate 2) and some of the retouching on her gown.

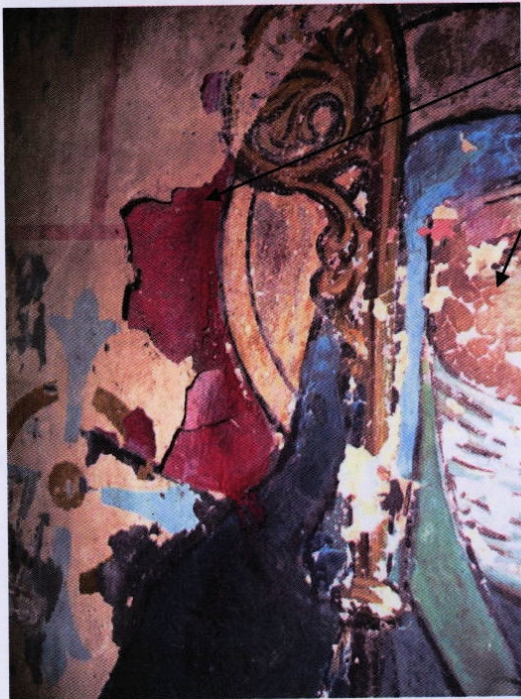
3

Detail of the flaking red paint.

Also note the cracked surface of the paint on her face.

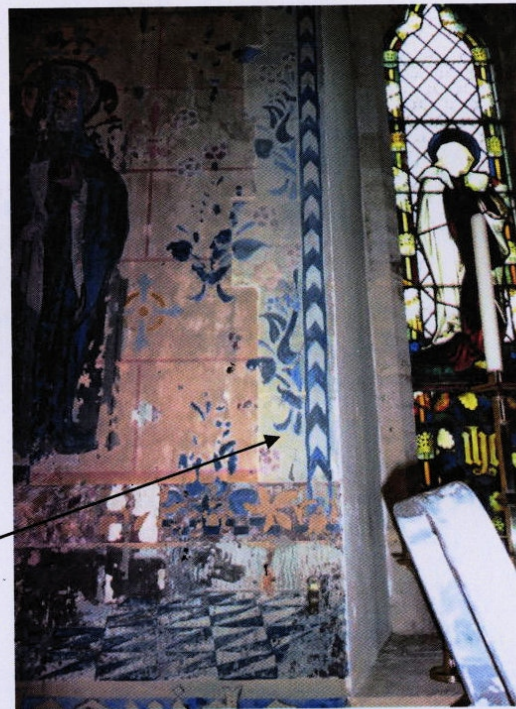
4

Detail showing the background of the second scheme painted on the area which was left unpainted for the first scheme.

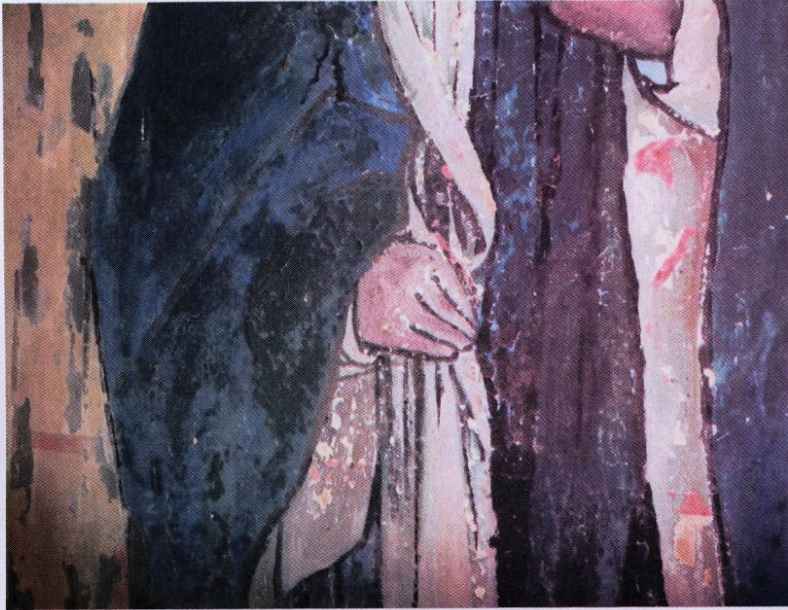
5.

Detail of St. Frideswide's robes. The darker areas are later retouching.

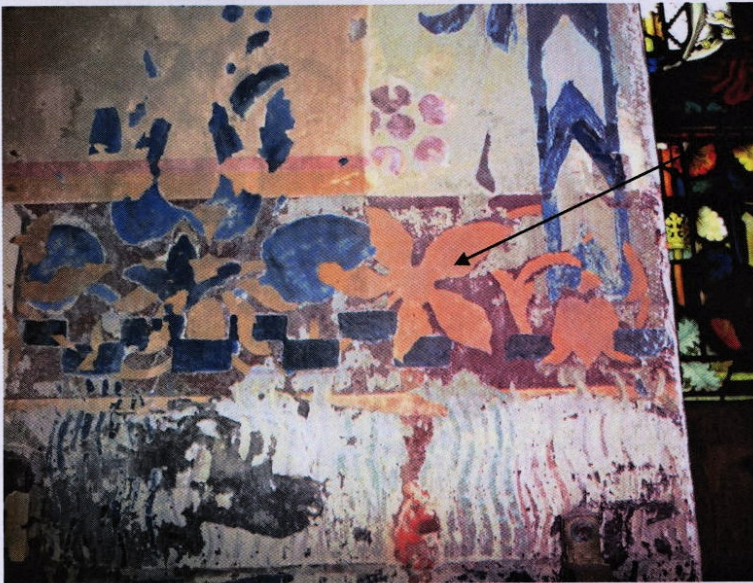
6.

Detail showing the dado border of the first scheme which is exposed.

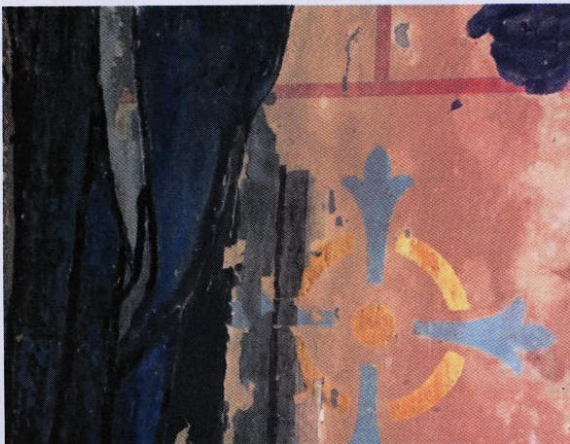
7.

Detail showing the foliated cross decoration from the first scheme.

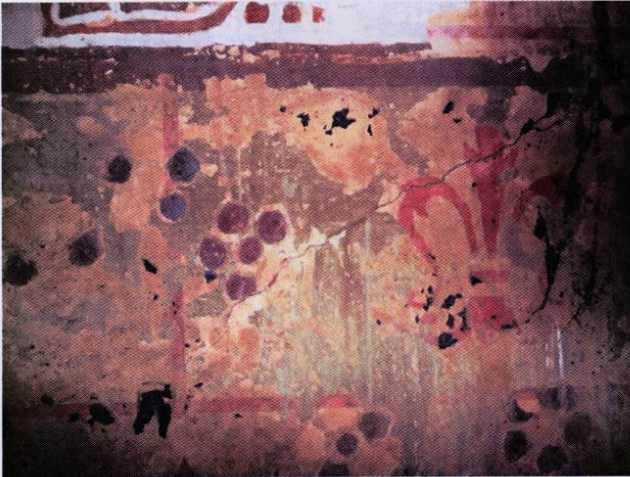
8

Detail showing the remains of the background decoration of the second scheme. The pink fleur de lys is part of the first scheme.

Note the dirt on the surface

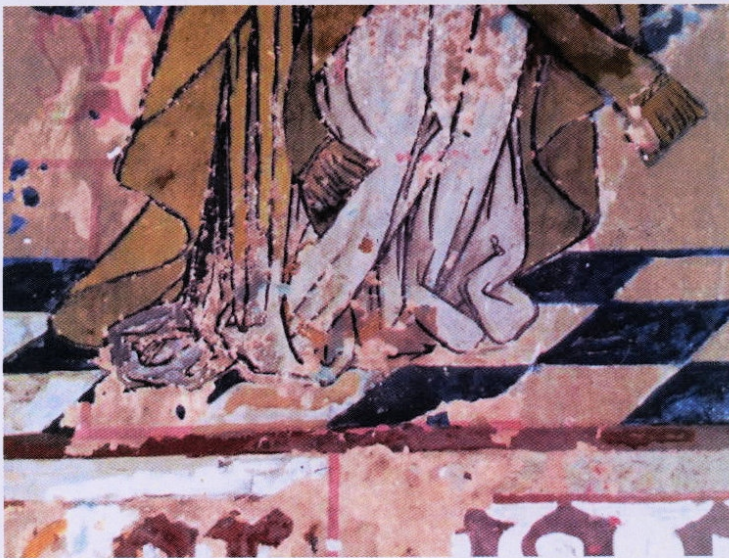
9.

Detail showing the lower half of the angel's robes. Much of the chequered floor has been retouched.

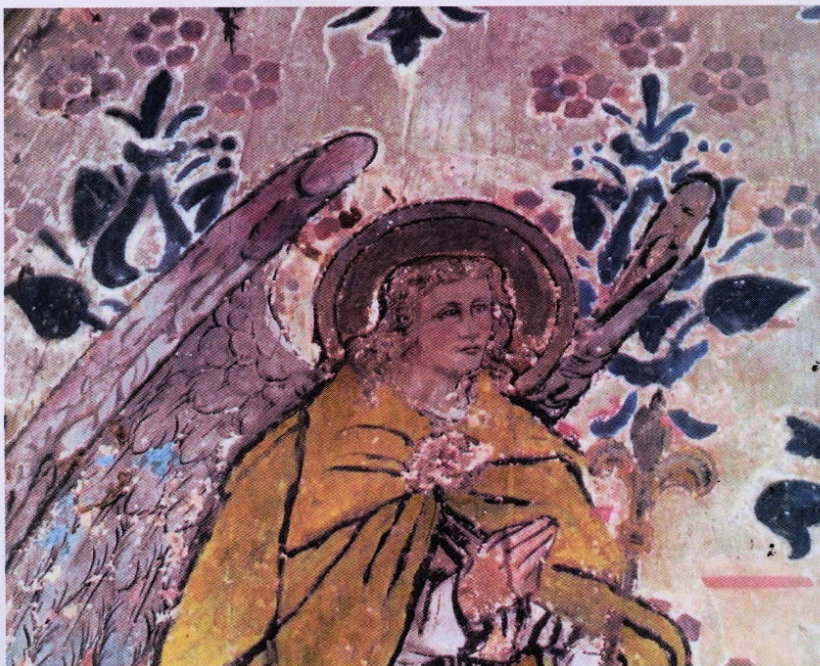
10

The Angel Gabriel. Much of this surface is covered with a coating of dirt and soot. The yellow cloak and the top end of the wings have been retouched.

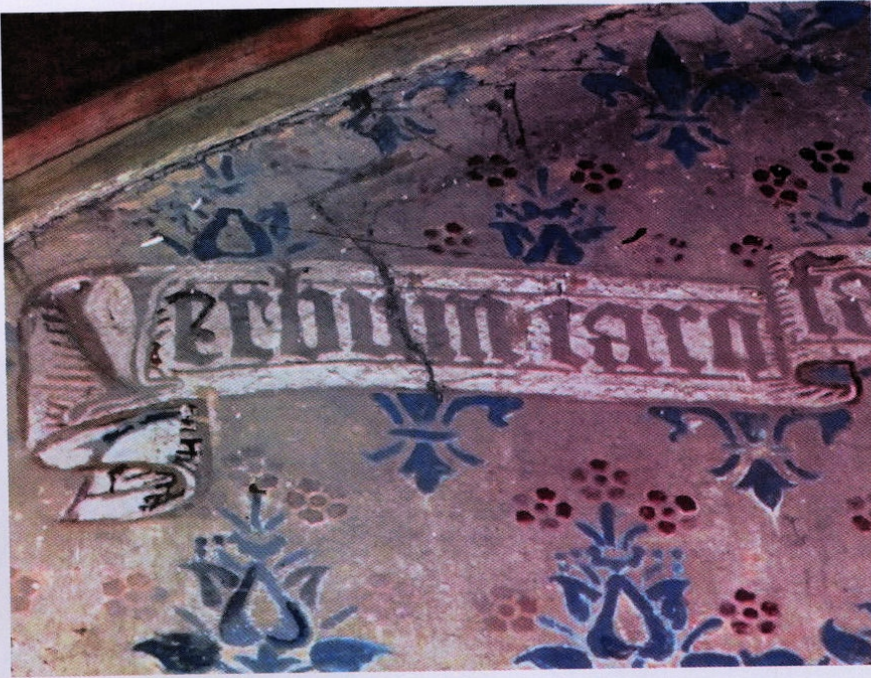
11

Upper section of the wall. The second scheme has generally survived better in this area. Unfortunately there has been some crude retouching on the scroll. Some of the leaves and flowers have also been retouched with a slightly darker colour.

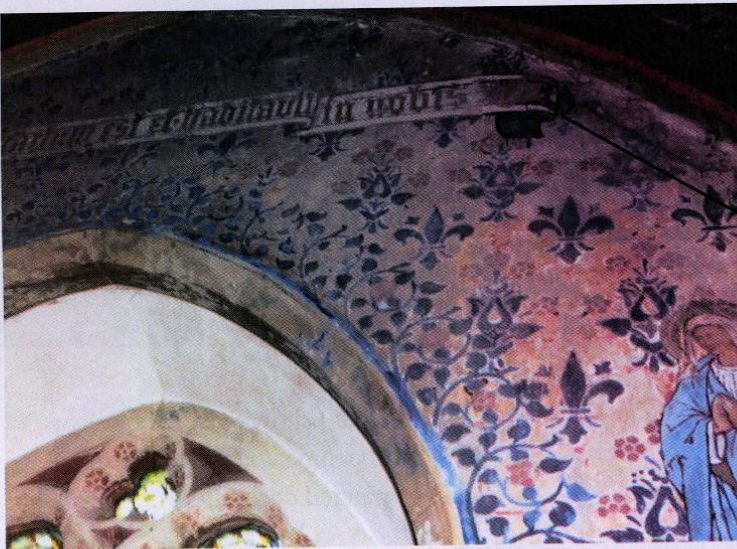
12

Upper area showing the poor retouching at the south end of the scroll.

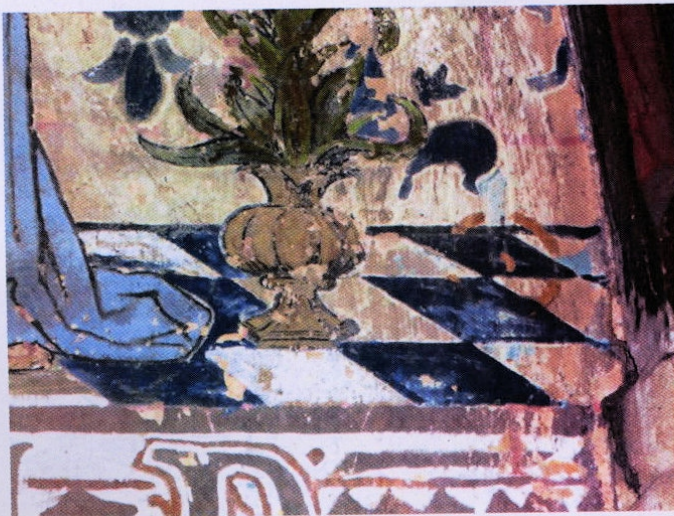
13

Detail showing area damage by water runs. The green on the lily leaves has a darkened appearance as though it may have a coating applied.

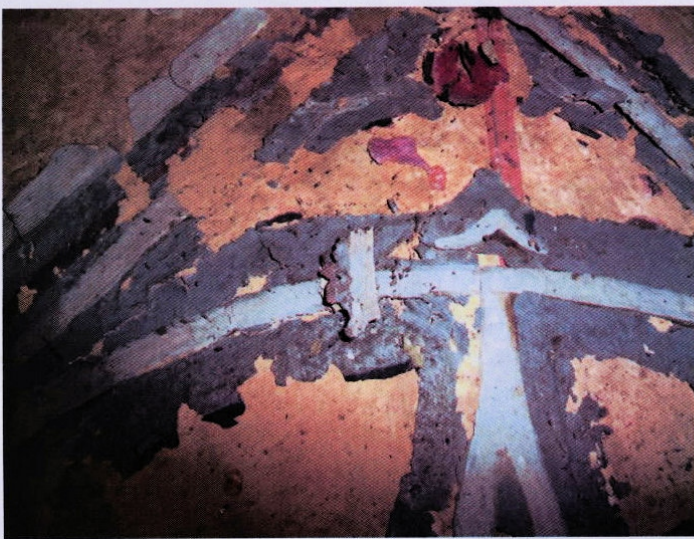
16

Detail showing severe loss of attachment and flaking of the painted decoration.

Areas where the paint is detaching should be faced up with Japanese tissue applied with Tylose (hydroxyl propyl cellulose). Once the tissue is secure the consolidant can be injected behind the flakes which are then gently pressed flat using a cotton wool pad wrapped in Melenex. Where necessary the paint can be softened using radiant heat before being pressed flat.

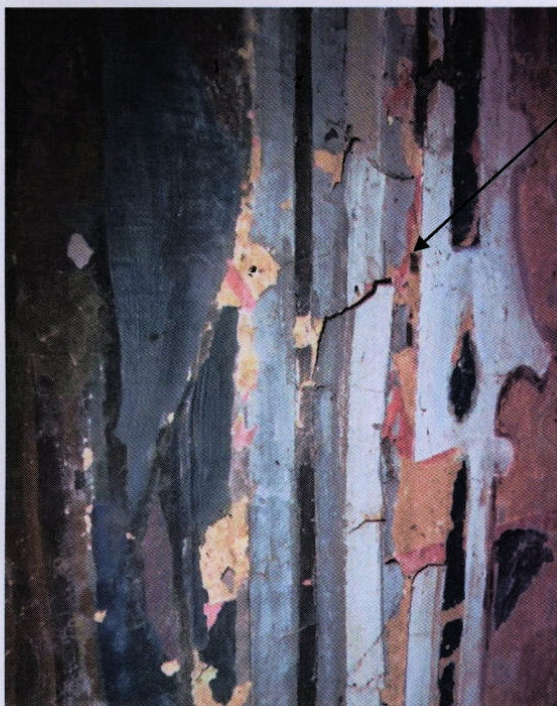
17

Detail showing detachment of the second painted scheme.

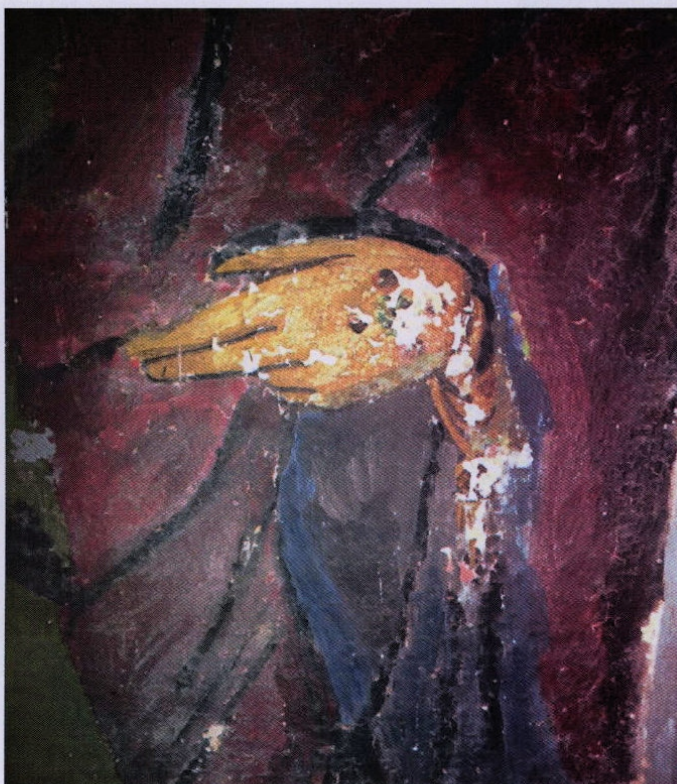
18

Detail showing St. Britius' hand. The purple colour of his robe has been fairly heavily retouched

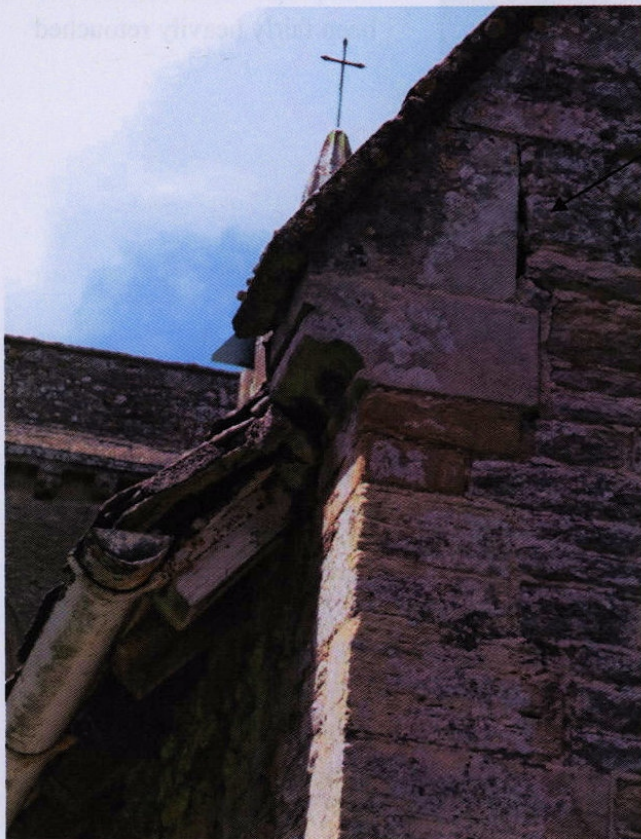
21

Detail of the south east corner of the exterior east wall showing an area that requires pointing.

Prior to any work being undertaken on the wall painting it is important that all necessary exterior repairs to the building have been carried out, to ensure that there is no moisture ingress at the junction between the roof and the east wall.
